## Boat-Wave-Induced Bank Erosion on the Kenai River, Alaska

Stephen T. Maynard, David S. Biedenharn, Craig J. Fischenich,  
and Jon E. Zufelt

March 2008

Final report

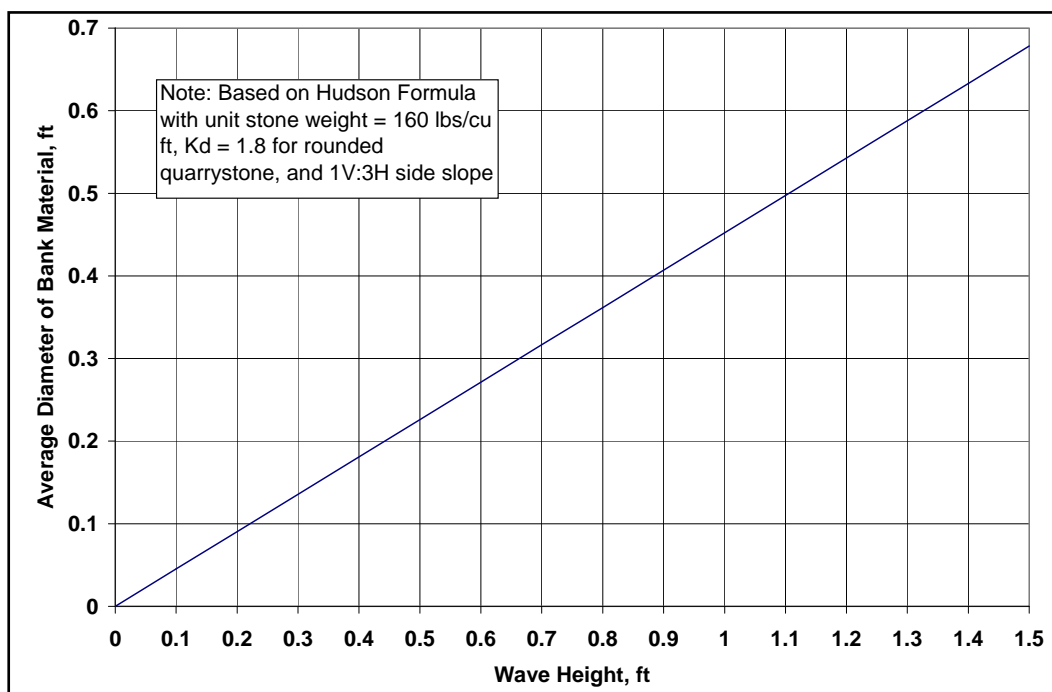
Figure 31. Relationship of bank material size and wave height required for movement.

where  $W_{50}$  is average weight of particle in pounds,  $\gamma_r$  is unit weight of rock = 160 lb/ft<sup>3</sup>,  $H$  is the wave height,  $K_D$  = stability coefficient = 1.8 applicable to rounded material and used for the cobble banks,  $S_r$  is the specific gravity of rock =  $\gamma_r$ /unit weight of water, and  $\theta$  is the bank angle assumed here to be 18.4 deg.  $W_{50}$  is converted to average diameter  $D_{50}$  using the equation for a sphere. Stone diameter versus wave height is shown in Figure 31 and Table 9. The Hudson equation is strictly applicable to large particles and does not apply to particle sizes where cohesive properties become significant. Based on the boat wave energy plot in Figure 30 and the fact that boat wave energy is a function of wave height squared, estimated wave heights on the left bank at RM 11.3 likely approach an  $H_{1/100}$  wave height of 0.91 ft that is capable of moving material of 124 mm (0.41 ft). At the same location, the significant wave height of 0.46 ft is capable of moving 63 mm (0.21 ft) material.

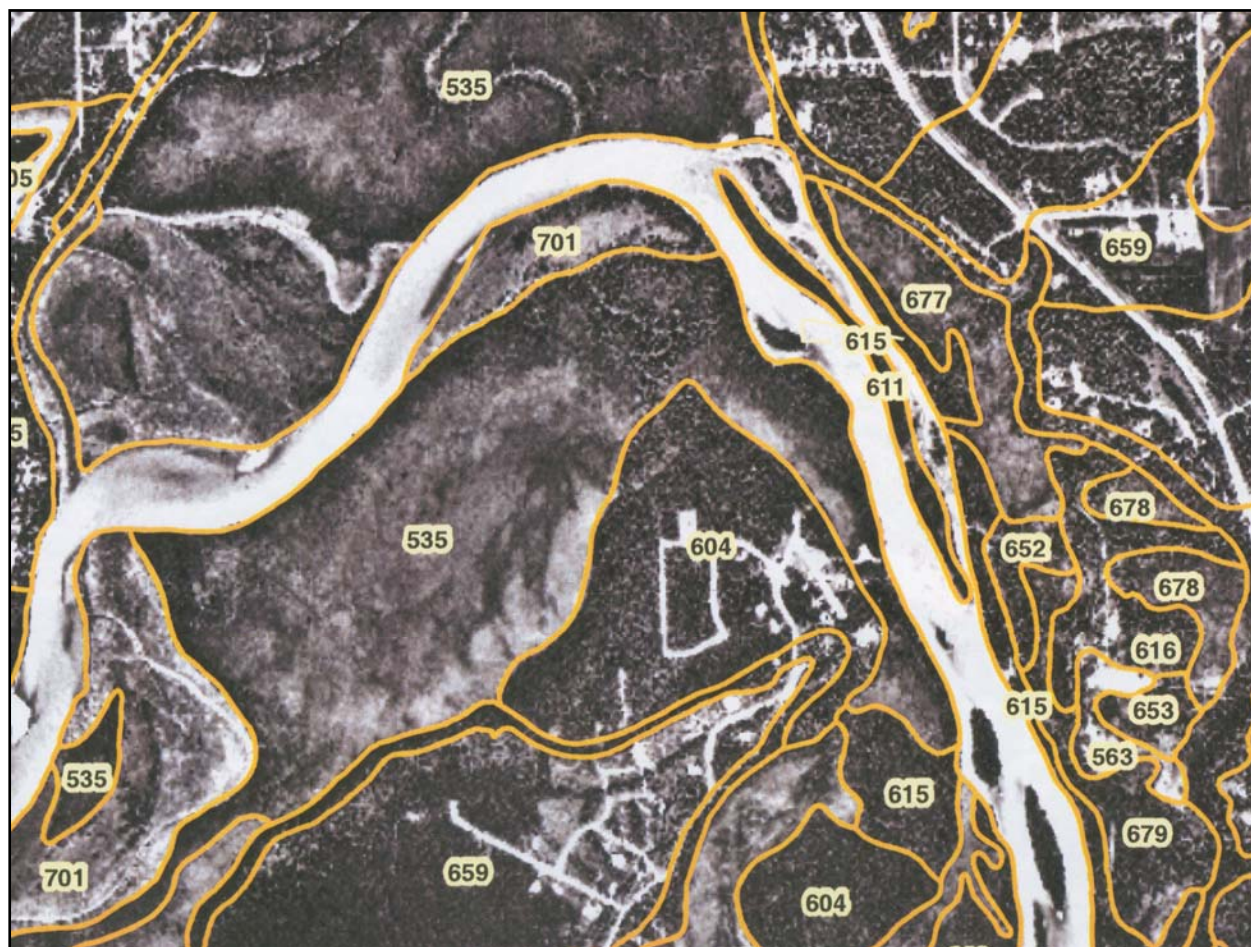
Figure 32. Soil map from NRCS (2004) of lower portion of study reach.

Figure 32 depicts a portion of a soil type map from the Natural Resources Conservation Service (NRCS 2004) of the lower portion of the study reach. The NRCS soil maps cover the entire study reach. The numbers in each subarea correspond to soil types described in the NRCS report. For example, soil type 535 is a Clunie peat having representative profile of 0 to 33 in. of peat and 33 to 60 in. of silty clay loam. Soil types 611 and 615 are commonly found along the study reach. Soil type 611 is a “Killey and Moose River” soil and has a representative profile of 0 to 2 in. of slightly decomposed plant material, 2 to 6 in. of silt loam, 6 to 29 in. of stratified fine sand to silt loam, and 29 to 60 in. of very gravelly coarse sand. Soil type 615 is a Longmare silt loam and has a representative profile of 0 to 3 in. of moderately decomposed plant material, 3 to 29 in. of silt loam, and 29 to 60 in. of sand. The soils of the Kenai lowlands are generally covered with glacial and terrace gravels (Qtg) and the tidal portions of the Lower Kenai River are composed of alluvial and beach deposits (Qal). Reger and Pinney (1997) describe the last major glaciation of the Kenai lowlands, which provides additional information on probable soil types. They surmise the extents of the four stages of the Naptowne glaciation and the evolution of the modern day channel of the Kenai River. At the maximum extent of glaciation, ice pushing south in what is now the Cook Inlet met ice pushing from Skilak and Tustumena lakes, forming a large impoundment in the vicinity of Sterling (labeled ST on Figure 33) and forming the Sterling Terrace formation. As the Cook Inlet ice receded, meltwater drained along its edge, forming the modern day Kenai River channel above Soldotna and flowing into another impoundment south of

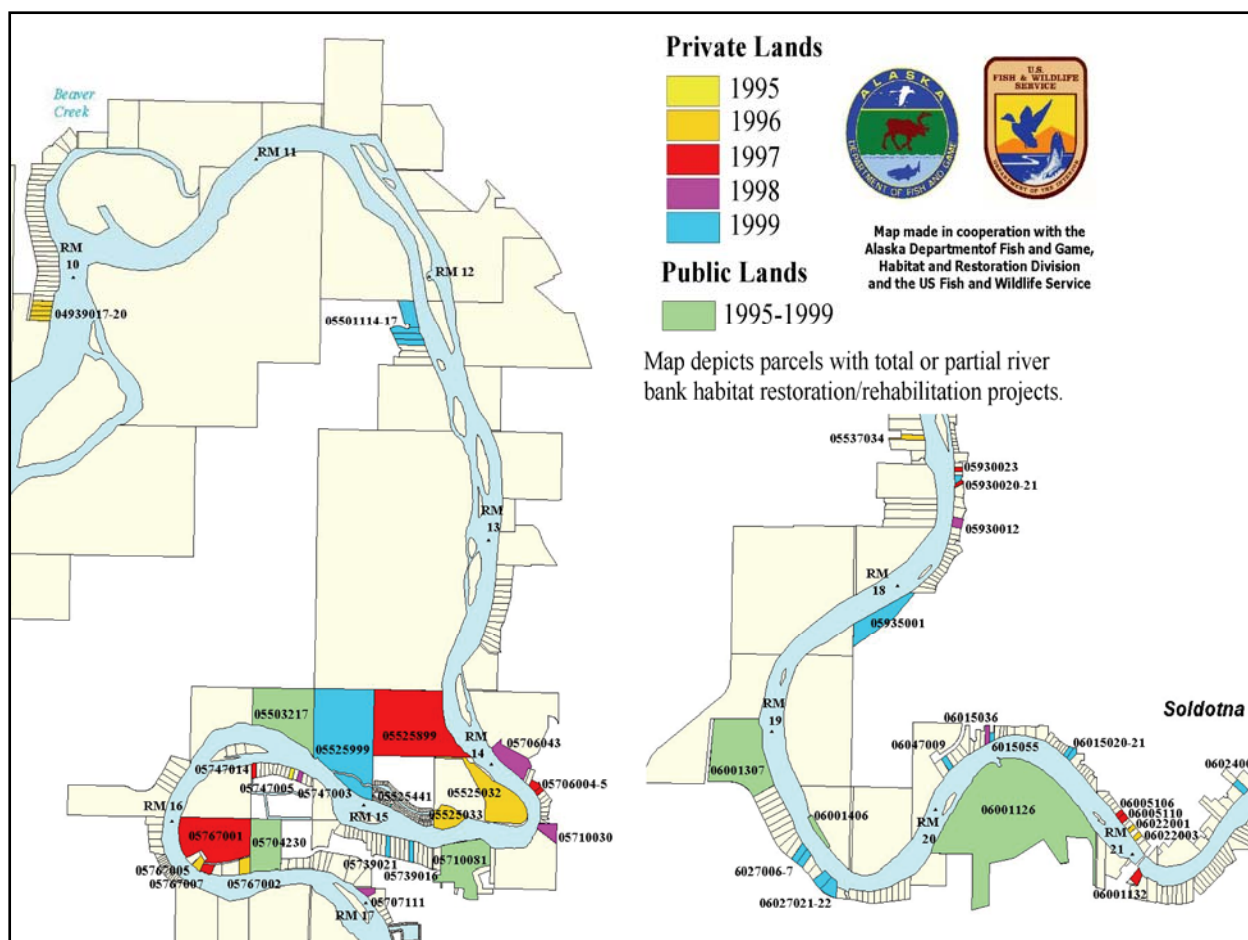
Figure 35. Map depicting permitted stabilization projects on the lower Kenai River.

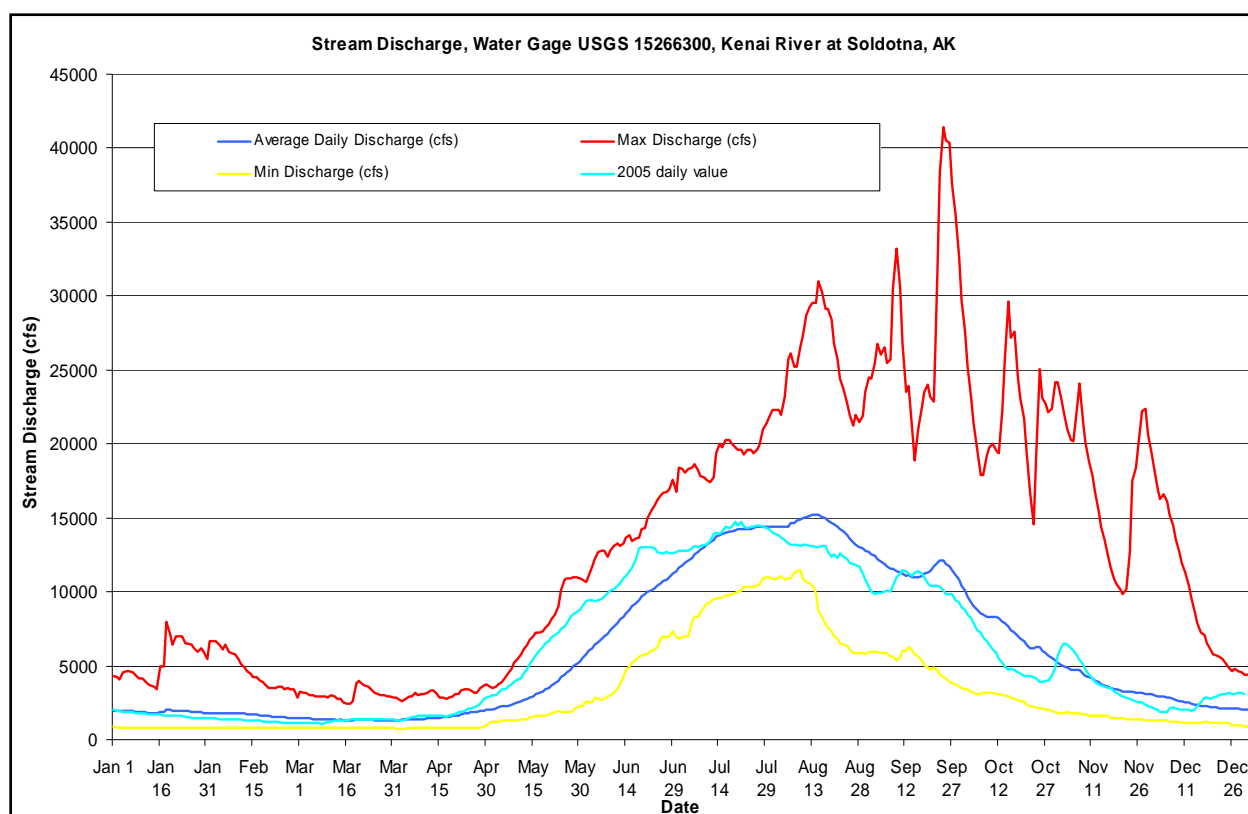
Figure 36. Hydrograph of the Kenai River at Soldotna.

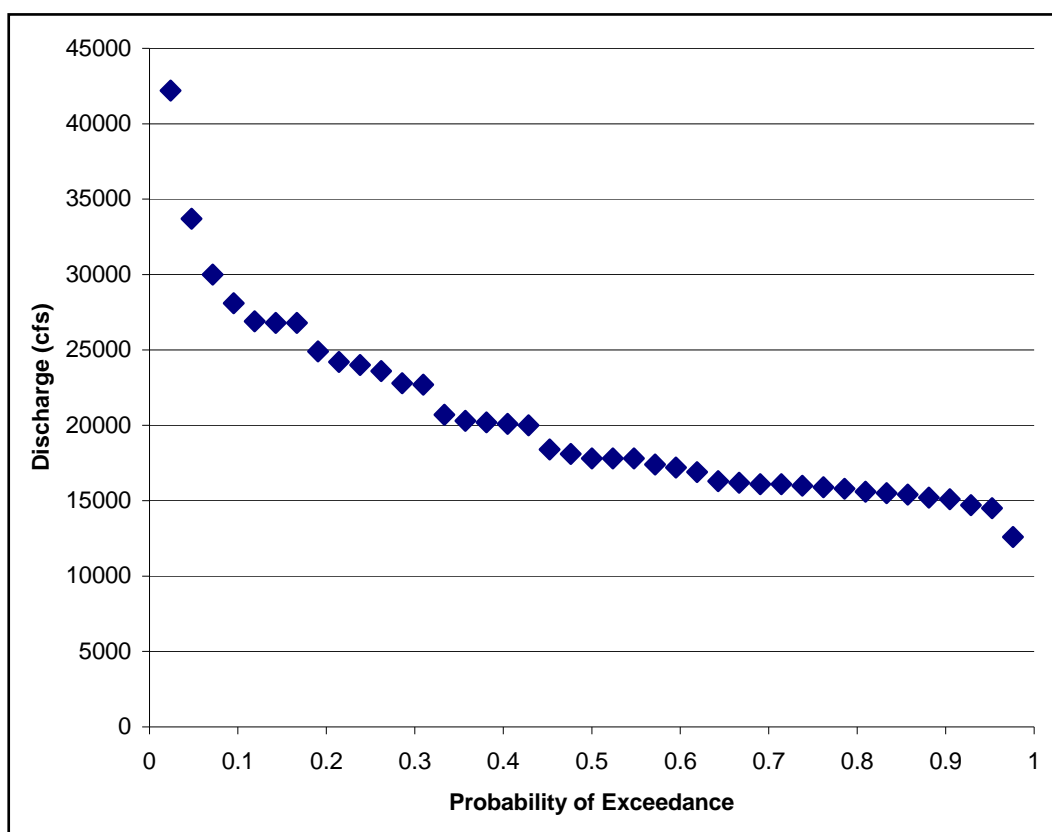
Figure 37. Discharge frequency curve for the Kenai River at Soldotna.

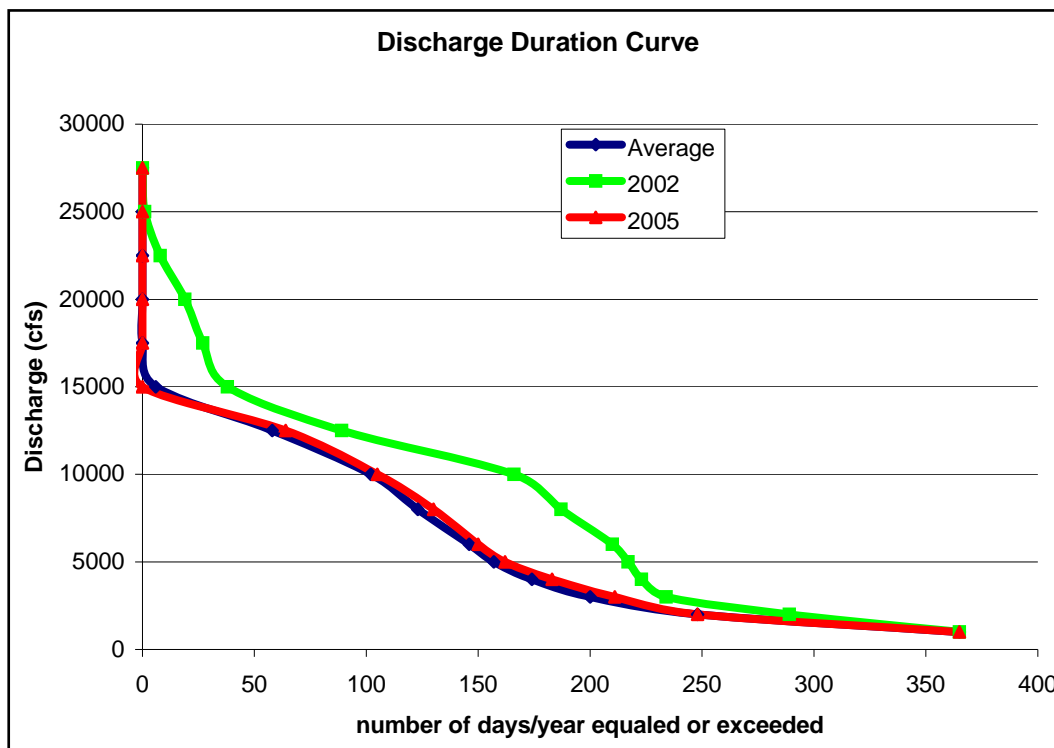
Figure 38. Discharge - duration curve.

shows that 2002 was a year with accelerated bank erosion due to the 38 days that year with discharges above 15,000 cfs.

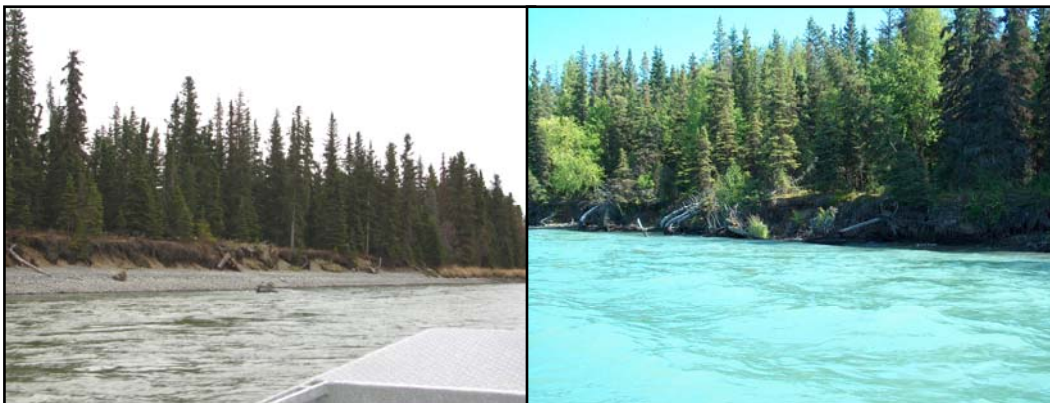
Figure 42. Stage at RM 13 (4 May 2005 and 22 July 2005).

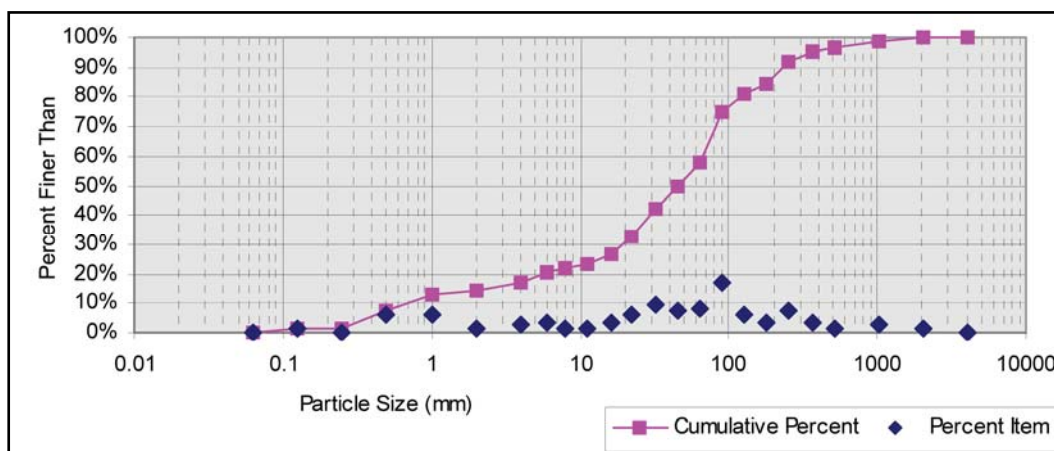
Figure 43. Grain size distribution of bar sediments – Kenai River near Big Eddy (RM 16).

Sediments on the bed of the Kenai River grade from coarse to fine with distance downstream. Wolman pebble counts of bar sediments obtained under low flow conditions (3800 cfs at Soldotna) on 24-25 May 2003 (Fischenich 2004) show that the  $D_{50}$  upstream of RM 13 is about 2 in., and a larger fraction of coarse sediments are found with distance upstream. Figure 43 presents an example grain size distribution, and Table 12 provides an average of bar samples collected upstream of RM 13. Pebble counts were not conducted downstream of RM 13 because the sediment is too fine. However, a study by Kinetic Laboratories (1998) included samples at RM 2, 3, 5, 10, and 13. The precise location of these samples is not noted in the report, but they demonstrate a  $d_{50}$  in the fine sand/coarse silt range. Lenses of gravel are present on the bed in this lower reach, particularly adjacent to high terrace/bluff features, but the bed material appears to be primarily sands.

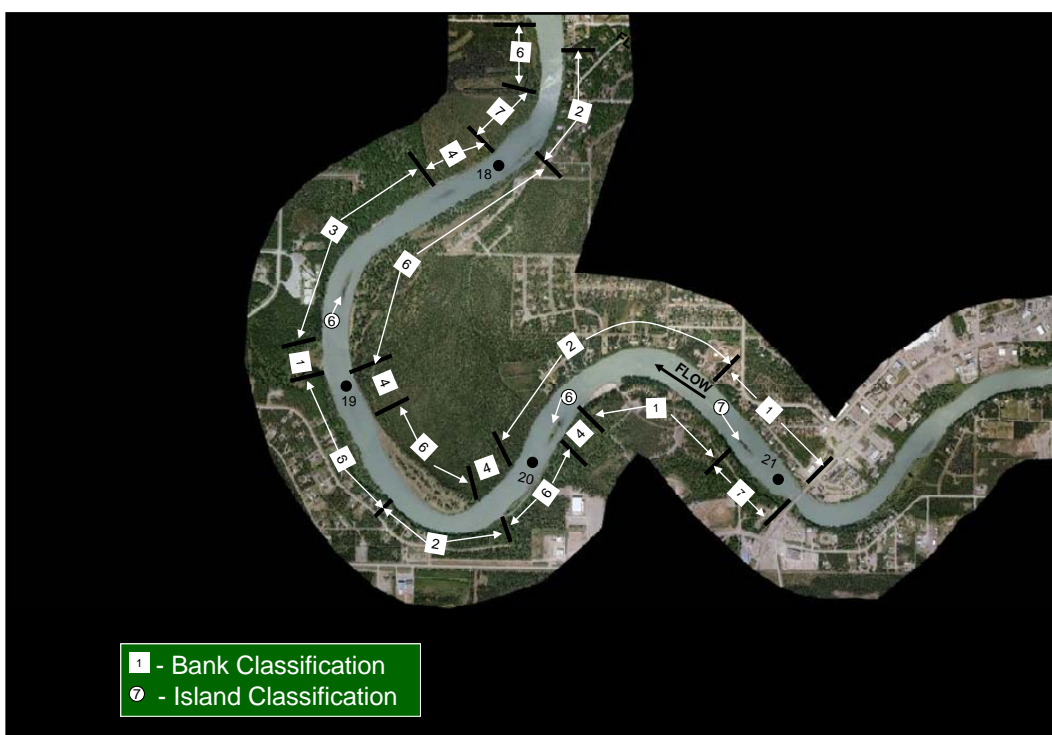
Figure 44. Bank and island classifications for approximate RM 21 to 17.5.

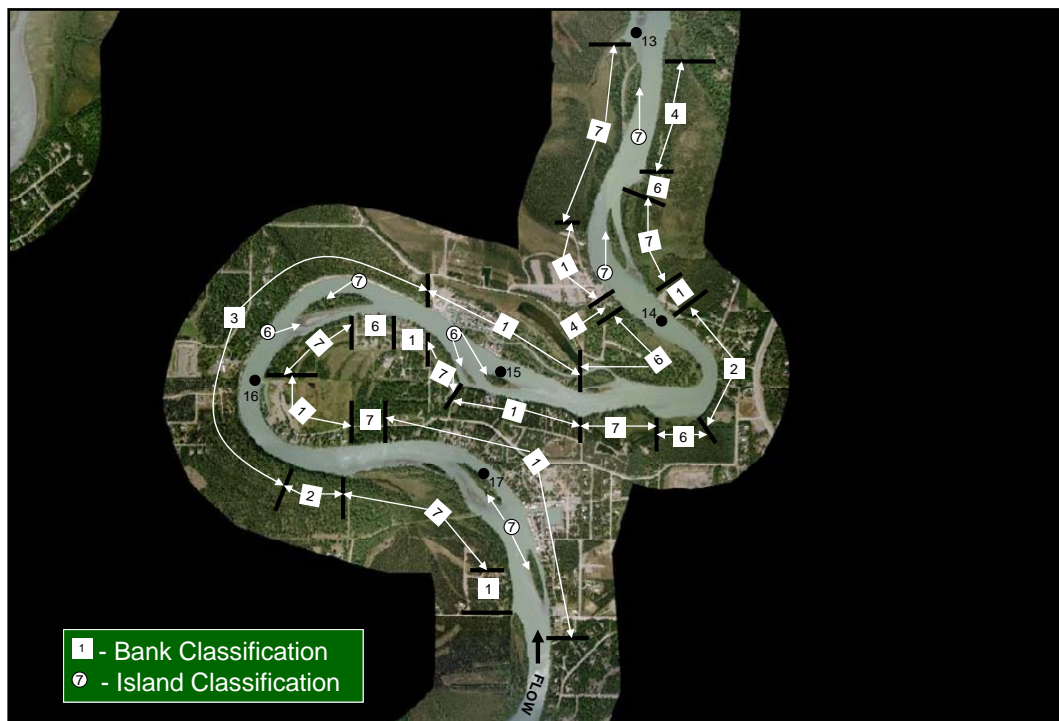
Figure 45. Bank and island classifications for approximate RM 17.5 to 13.

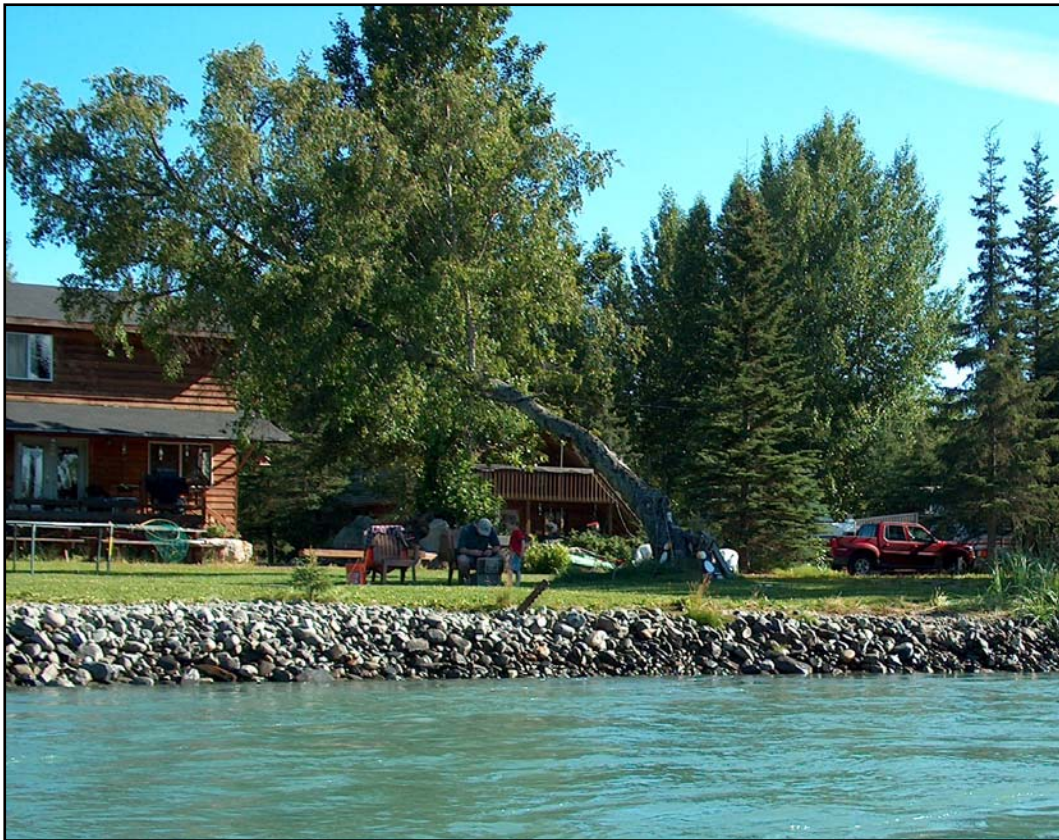
Figure 47. Type 1 bank stabilized with riprap.

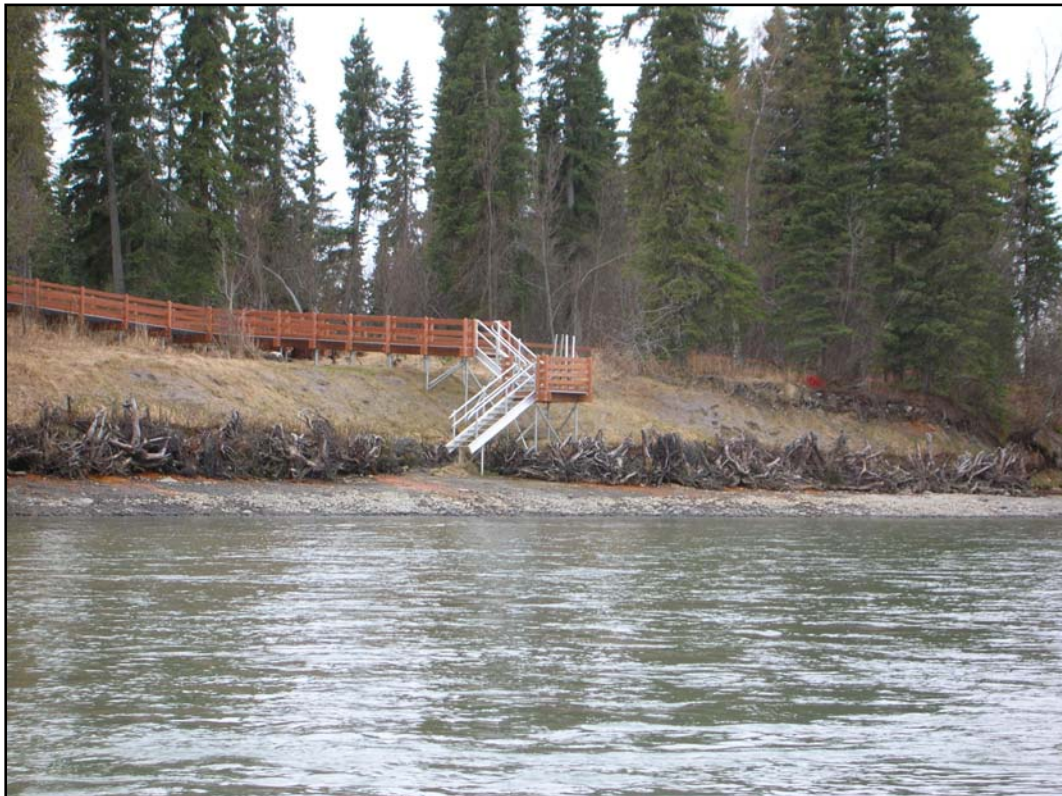
Figure 49. Type 1 bank with root wad habitat restoration.

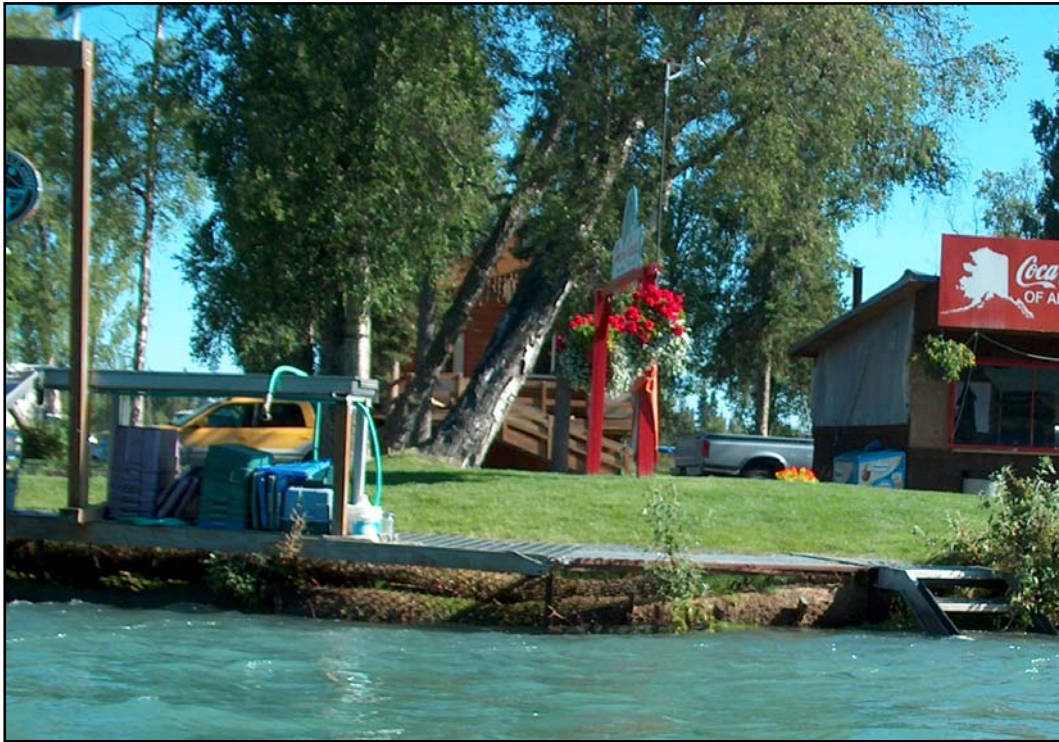
Figure 50. Type 1 bank with coir log habitat restoration.

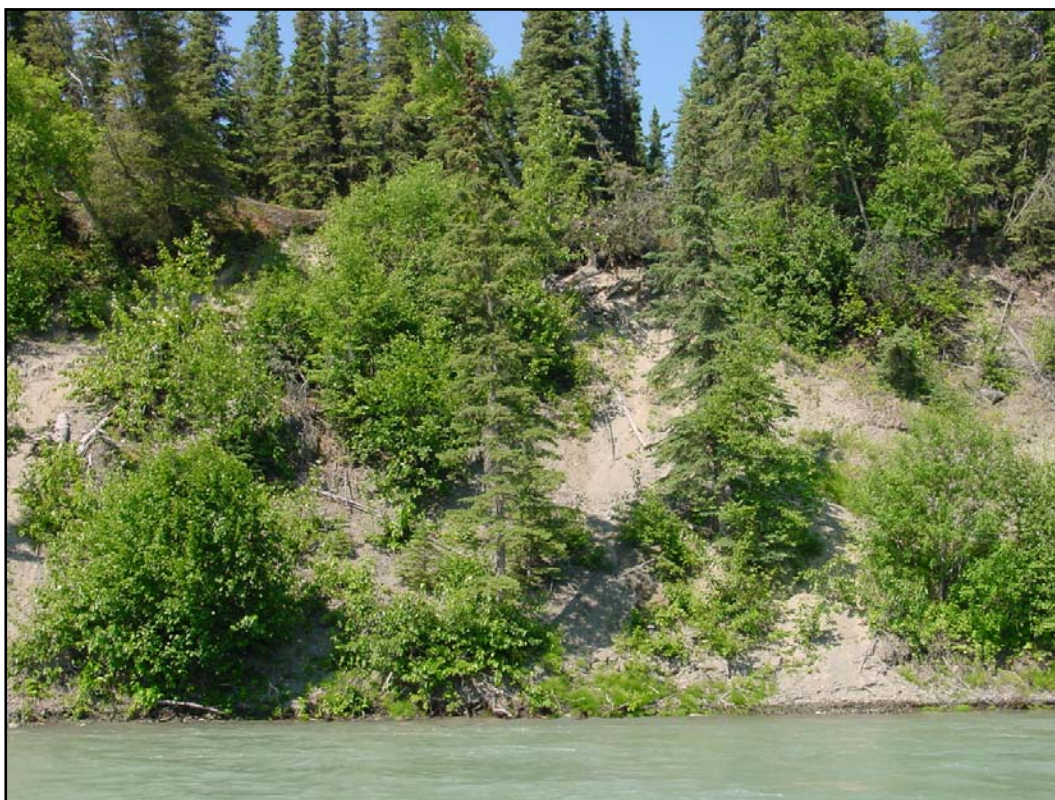
Figure 52. Type 2 bank, which is resistant to erosion at water line.

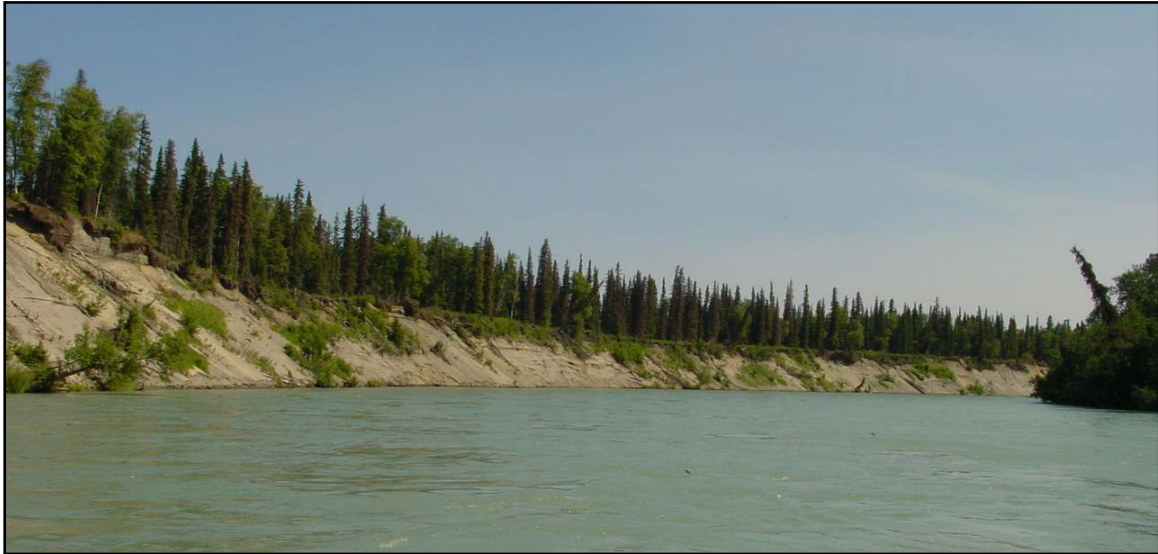
Figure 53. Typical Type 3 bank, predominantly void of vegetation.

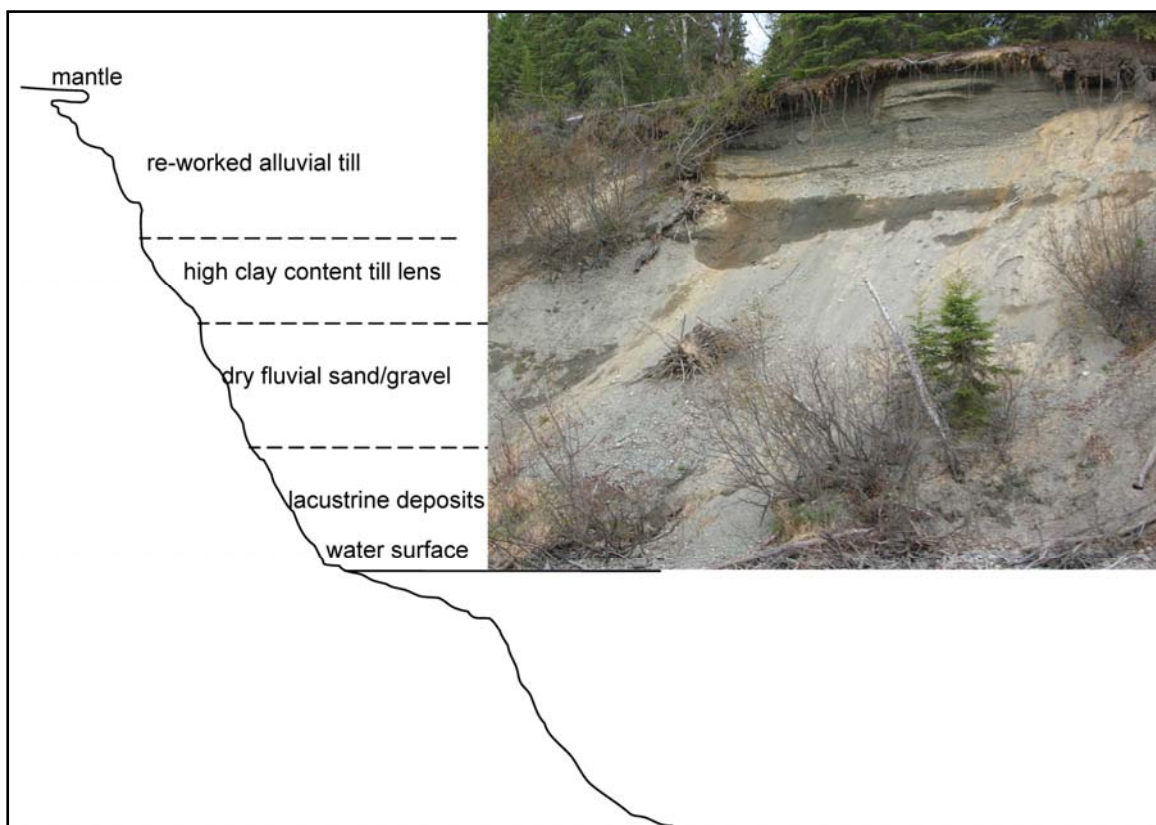
Figure 54. Schematic of Type 3 bank features. Water surface at a discharge of about 15,000 cfs.

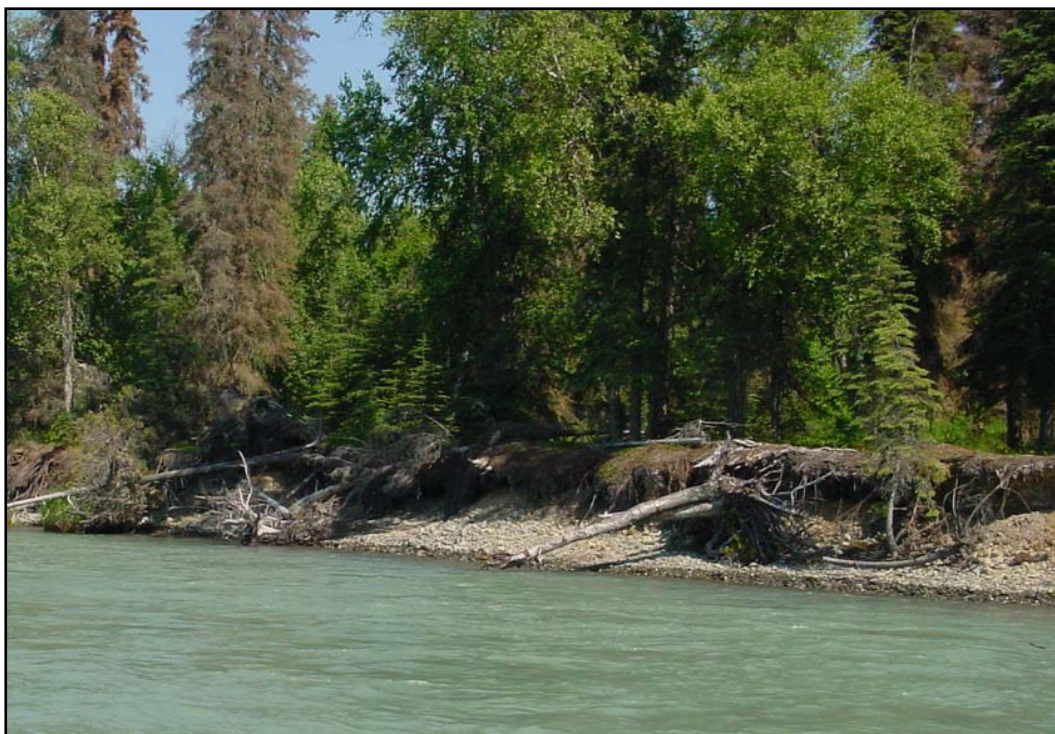
Figure 55. Typical Type 4 bank showing root/soil mantle draped over exposed bank face.

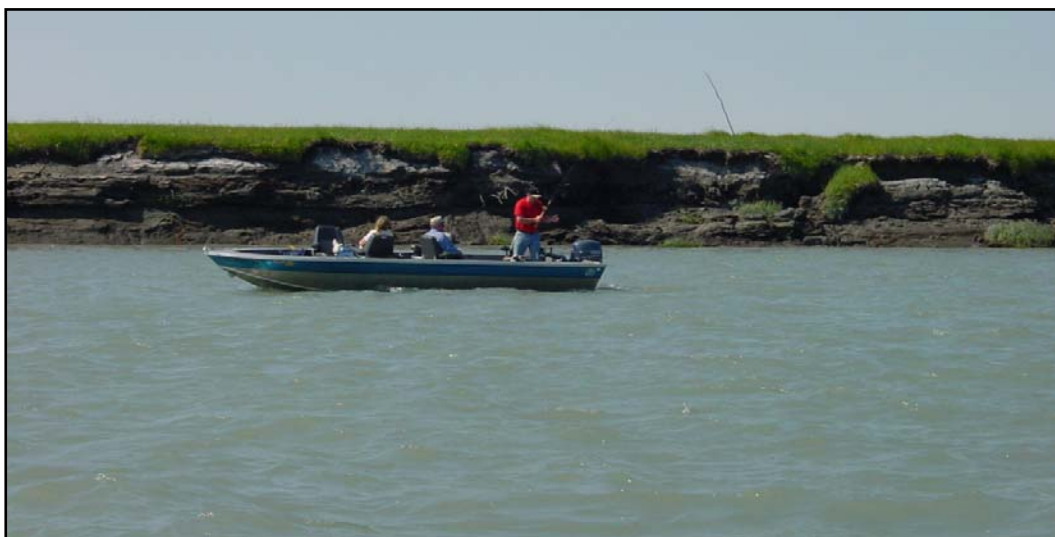
Figure 56. Typical Type 5 bank, which is highly susceptible to boat wakes.

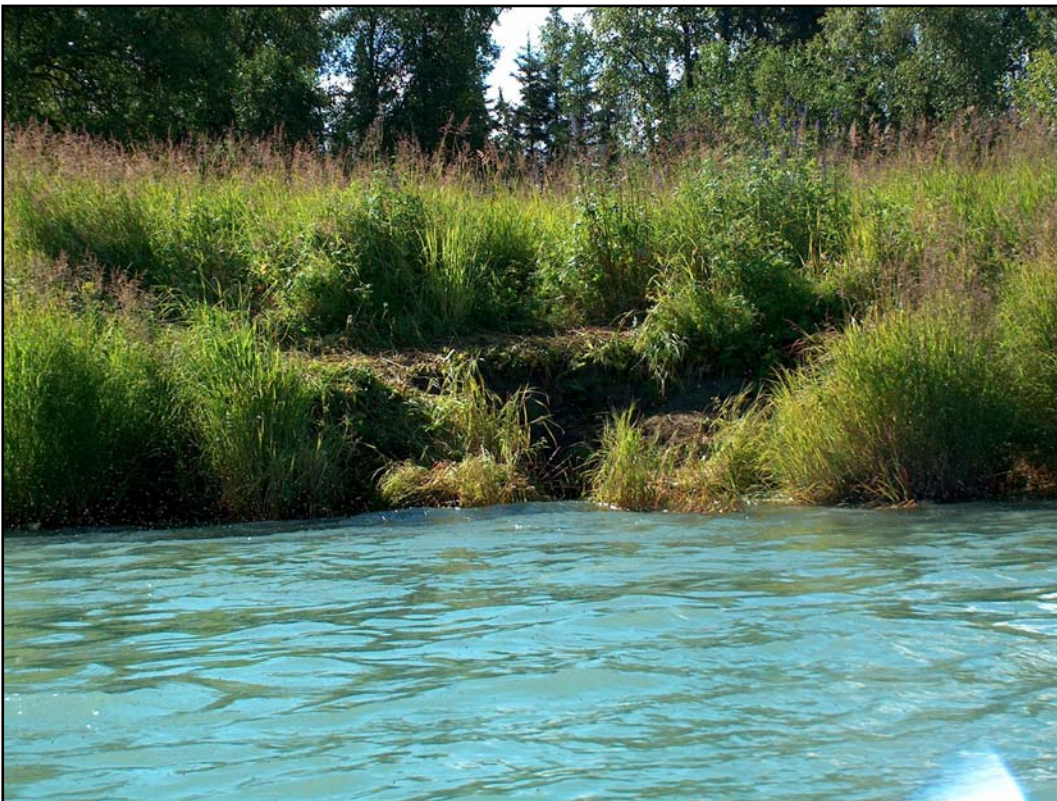
Figure 58. Trampling caused by bank anglers on Type 6 bank.

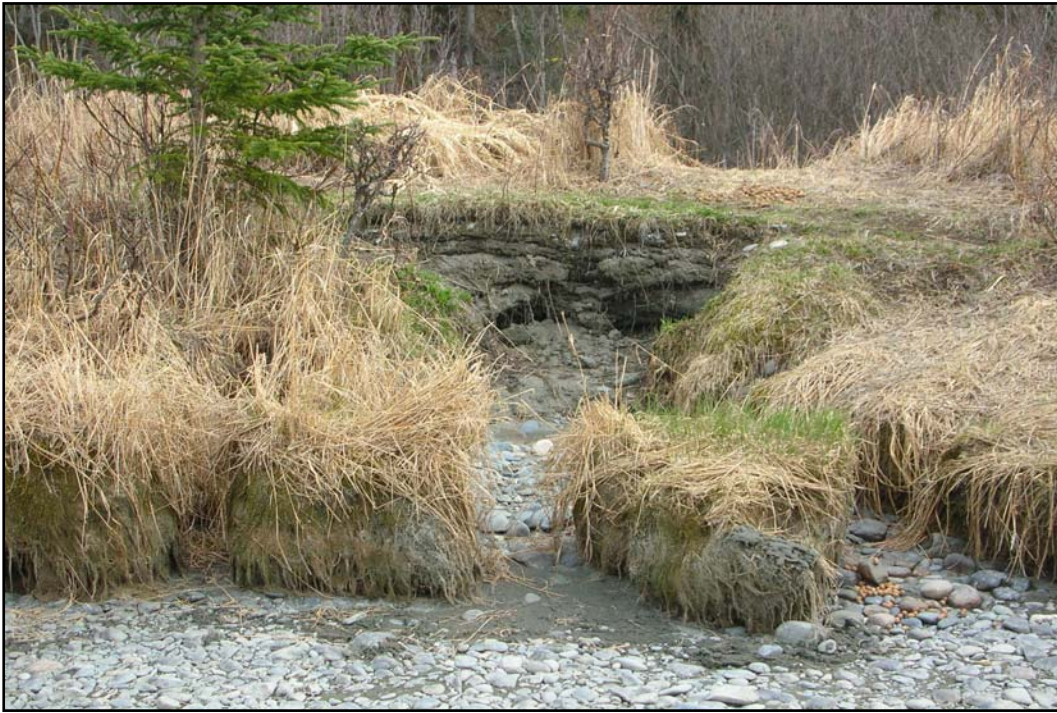
Figure 59. Type 6 bank failure mechanism.

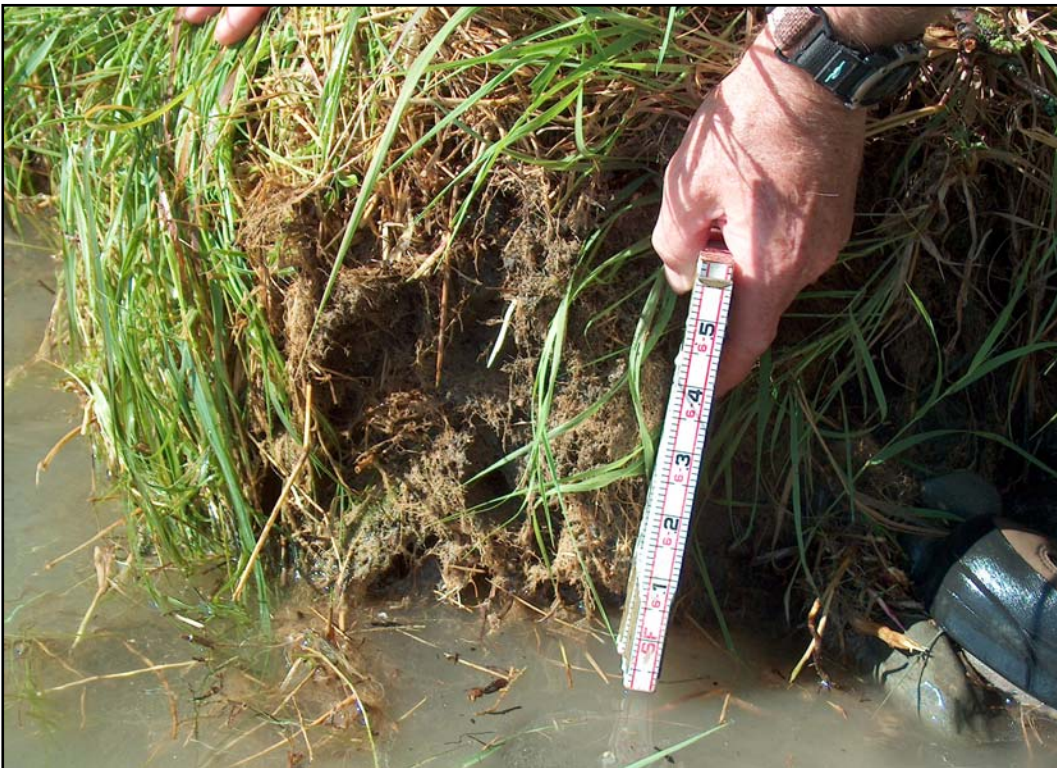
Figure 60. Root mass of herbaceous vegetation of Type 6 bank.

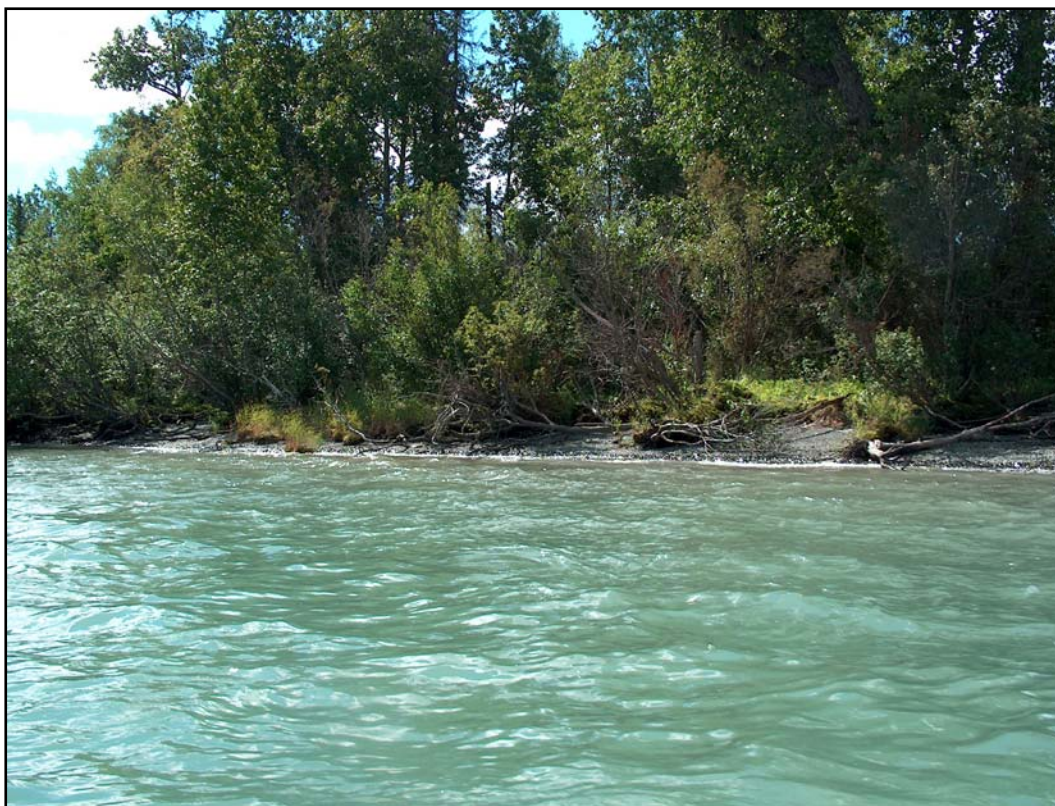
Figure 61. Typical Type 7 bank covered with woody vegetation.

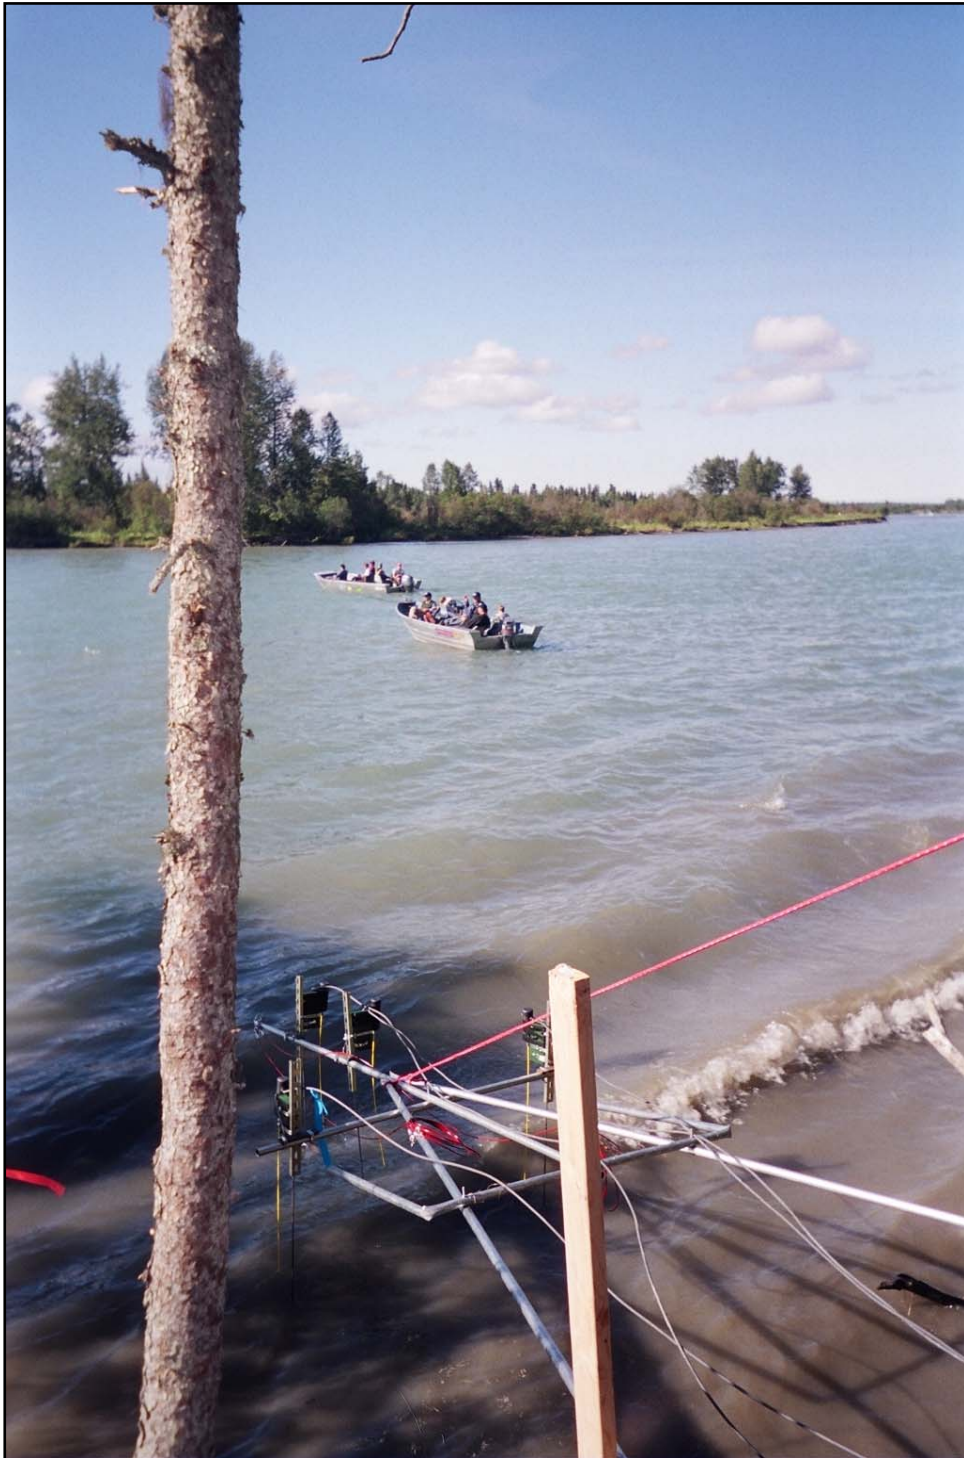
Figure 65. Near-bank turbidity at wave measurement site at RM 11.3.

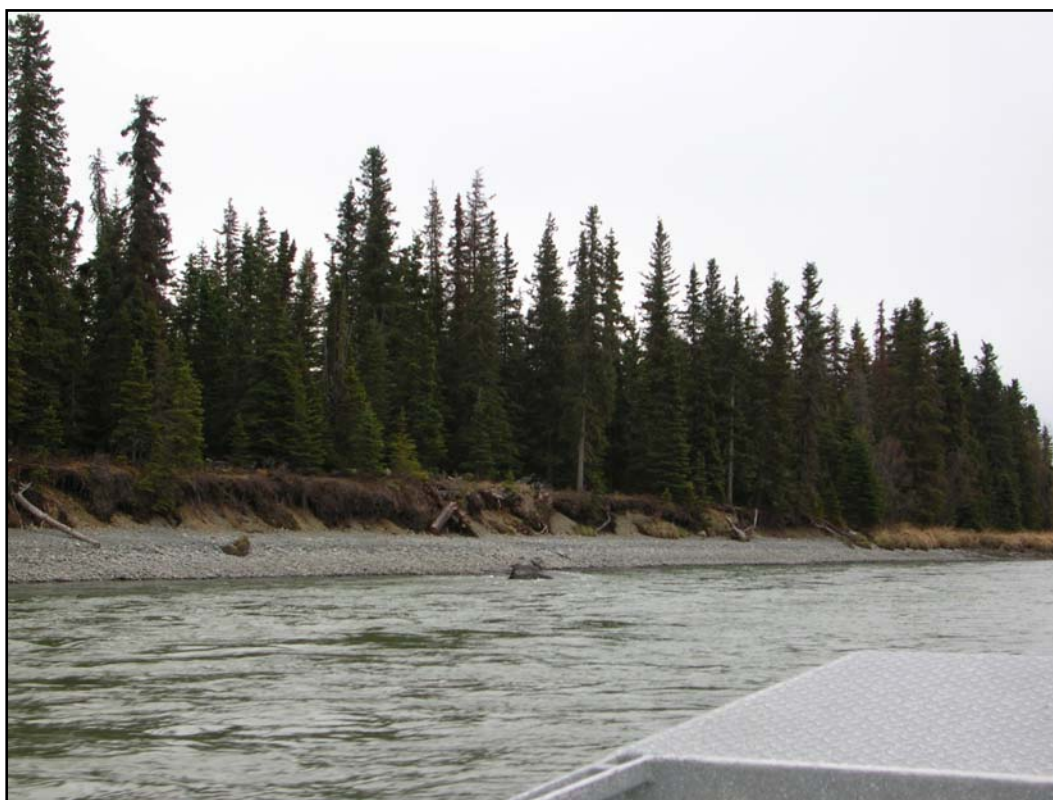
Figure 67. Cobble bench on Type 4 bank at low flow in May 2005.

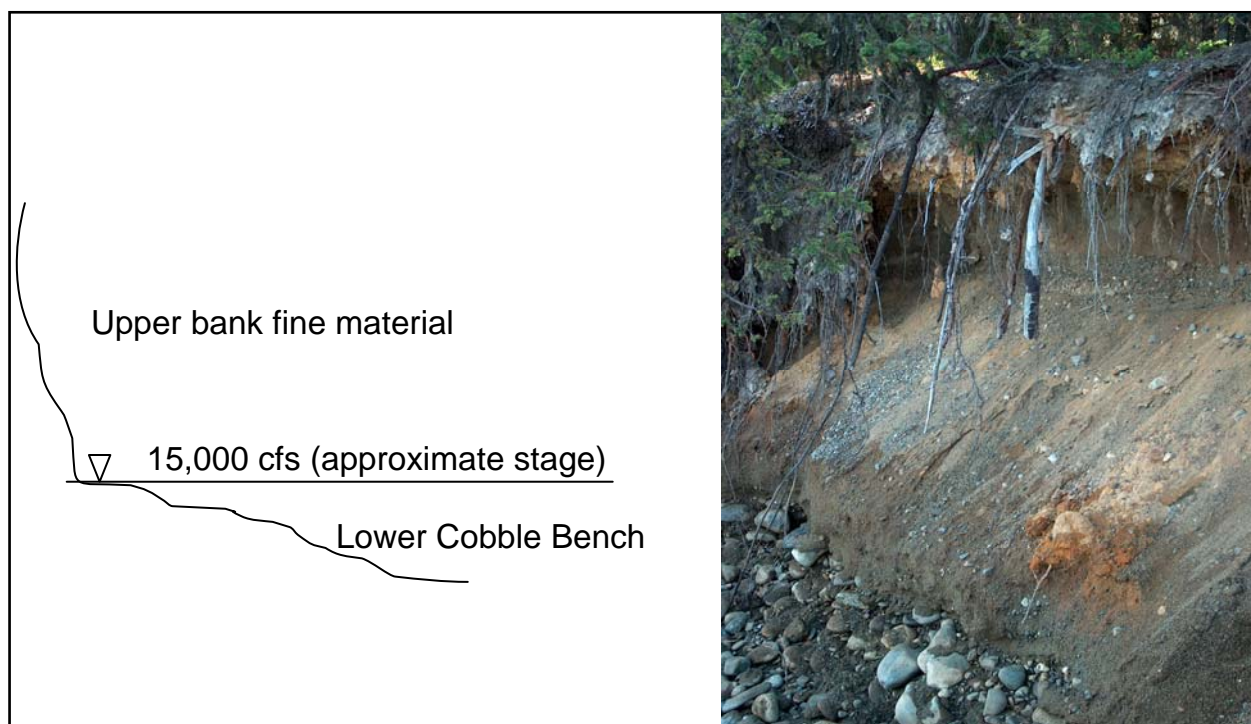
Figure 70. Typical bank profile showing relationship between lower cobble bench, upper bank, and 15,000 cfs flow.
